**PRODUCT LINE:** ACCESS

**PRODUCT NAME:** NGCR Mullion Reader

**MODEL(S):** VR50M-MF

**CATEGORY:** BUG FIX

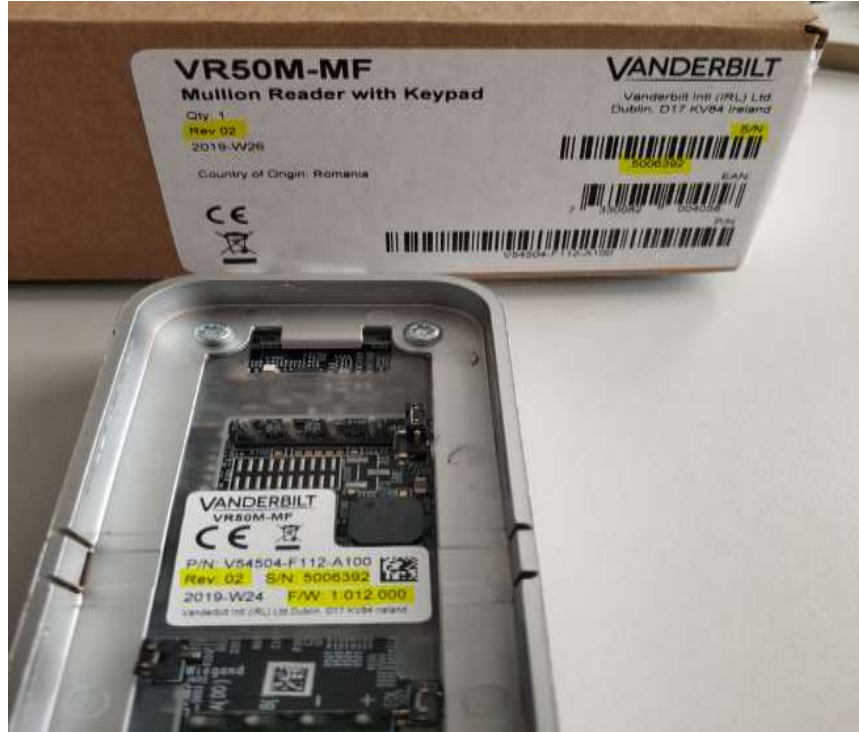
Please find below an example of where to find the product revision number, serial number and FW revision on both the product and packaging label.
