PRODUCT LINE:	ACCESS		
PRODUCT NAME:	NGCR Mullion Reader		
MODEL(S):	VR20M-MF, VR50M-MF	CATEGORY:	UPDATE
CONTACT:	Local Technical Support	DATE:	2020-11-20

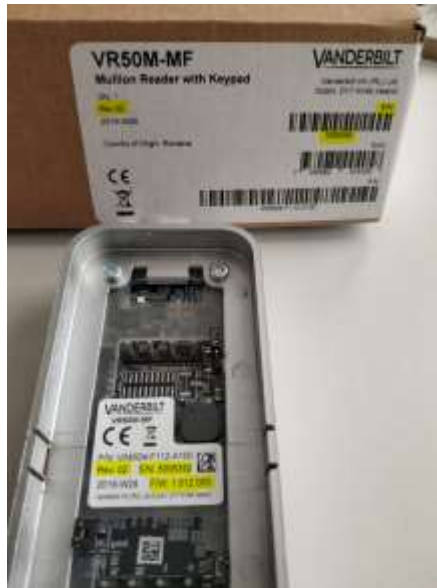
Please find below an example of where to find the product revision number, serial number and FW revision on both the product and packaging label.
